CITY OF NORTHVILLE

MAINCENTRE PARKING STRUCTURE | DRAFT REPORT

24183249.00 | June 128, 2018 | Engineering Condition Assessment

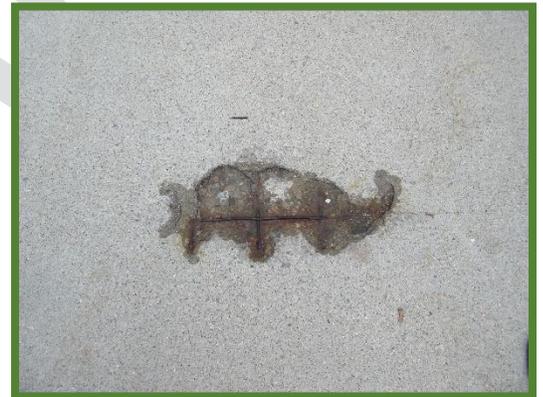
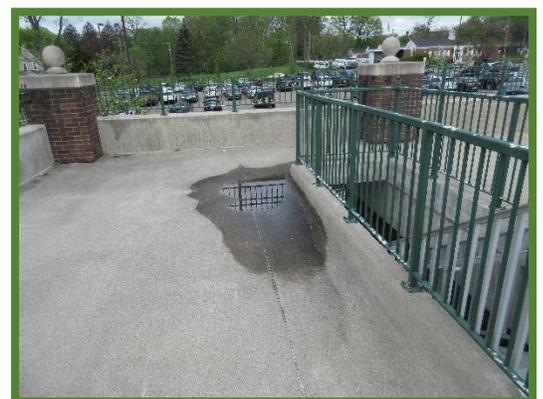
The chain drag survey of the floor slabs revealed approximately 400 square feet of slab delaminations at the Upper Level, which is approximately 1.4% of the supported slab. Most of the top-of-slab delaminations are small, approximately 1 to 4 square feet in size. Many of the delaminations are caused by the corrosion of the welded wire fabric which appears to have very little concrete cover. Floor slab delaminations should be repaired to help maintain the structural integrity of the facility and eliminate safety hazards such as trip hazards.

Water ponding was observed at the Upper Level Adjacent to the southwest stairs. This ponding could be relieved by minor re-profiling or installing a supplementary floor drain.

- 3.1 *Top of Slab Repair* – This item includes repairing the delaminated/spalled concrete in the concrete topping at the Upper Level.
- 3.2 *Tee Flange Repair* – This item includes repairing delaminated concrete at the precast tee flanges.
- 3.3 *Beam Repair* – This includes the repair of beam delaminations at the underside of the Upper Level.
- 3.4 *Column Repair* – This item includes the repair of column delaminations throughout the structure.
- 3.5 *Spandrel/Wall Repair* - This item includes repairing delaminated concrete at the spandrels/walls.
- 3.6 *Curb Repair* - This item includes the repair of curb delaminations at the entrance/exit at the Upper Level.

- 22.1 *Supplemental Floor Drain* – This item includes installing an additional drain and associated piping where water is ponding along the southwest stairs.
- 22.2 *Replace Damaged Storm Drainage Piping* – This item includes replacing the damaged vertical risers at the Lower Level.

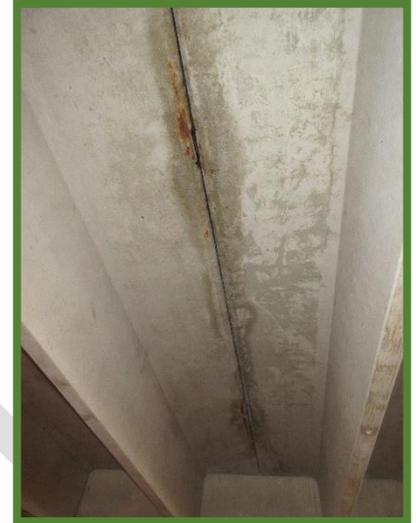
Tee Flanges/Stems

The double tees appear to be in good condition. We estimate a total of 20 square feet of tee flange delaminations, with most of them approximately 1 to 3 square feet in size. The delaminations are typically located along leaking joints that allow water and chlorides to corrode embedded reinforcement. These delaminations should be repaired to help maintain the structural integrity of the facility and eliminate safety issues such as falling concrete.

The tee stems appear to be in good condition. No delaminations were noted at the stems.

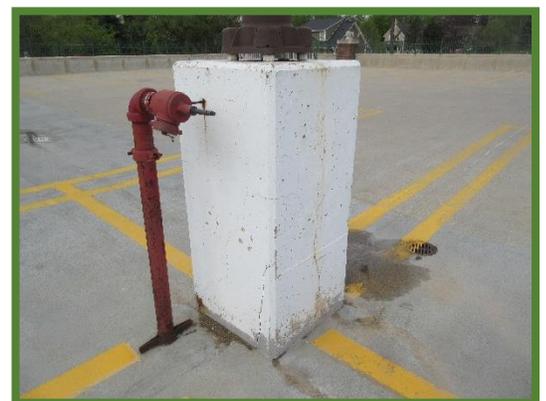
Columns

The columns appear to be in good condition with a total of 40 square feet of delaminations. Most of the column delaminations are small, approximately 4 to 5 square feet in size and primarily located along column line B at both the Upper and Lower Levels.

The delaminations at the Lower Level are typically located at leaking joints that allow water and chlorides to corrode embedded reinforcement. These delaminations should be repaired to help maintain the structural integrity of the facility and eliminate safety issues such as falling concrete.

The interior columns at the Upper Level, a total of three, are used to support the light posts. These columns have multiple hairline cracks, which may be from alkali-silica reaction (ASR). To help protect these columns we would recommend installing an elastomeric coating.

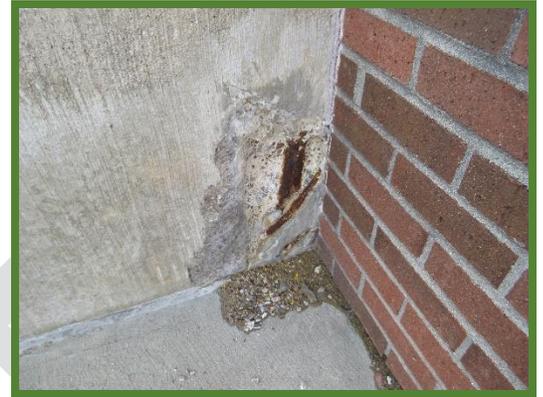
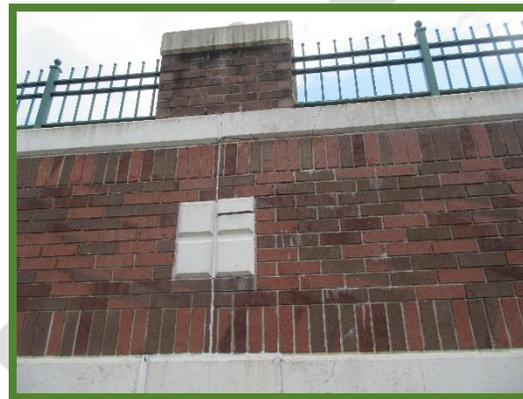
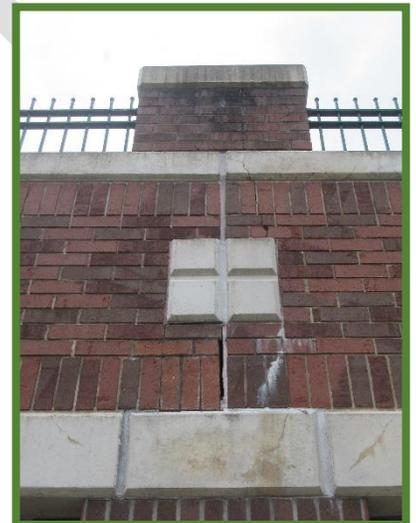
Spandrels

The precast concrete spandrels with brick veneer are located at the perimeter of the Upper Level. The spandrels appear to be in good condition with a total of 24 square feet of delaminations. Most of the delaminations are small, approximately 1 to 2 square feet in size and primarily located near the columns. The delaminations at the interior face are typically caused by the corrosion of the reinforcement with shallow concrete cover. The deterioration at the exterior face appear to be caused by failed sealants, which allows moisture to penetrate behind the brick veneer. The moisture can then attack the concrete causing corrosion of the reinforcement, especially if there is shallow concrete cover on this face. Also, once moisture is behind the brick, freeze-thaw can cause damage to the concrete and the brick.

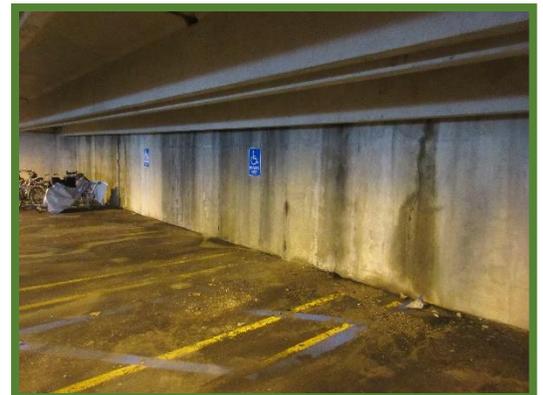
Walls

The cast-in-place concrete walls are located at the perimeter of the Lower Level. The walls appear to be in good condition with a total of 20 square feet of delaminations. Most of the wall delaminations are small, approximately 4 to 6 square feet in size. The wall at the north end has multiple leaking cracks, which has helped cause the delaminations. Also, the expansion joint above at the entrance has failed causing leaking on to the wall. The cracks and expansion joint needs be sealed to protect this wall.

- 7.7 *Recoat Deck Coating* – This item includes recoating all the existing deck coating.
- 7.8 *Inject Wall Cracks* – This includes injecting the leaking wall cracks at the north end of the Lower Level with chemical grout.

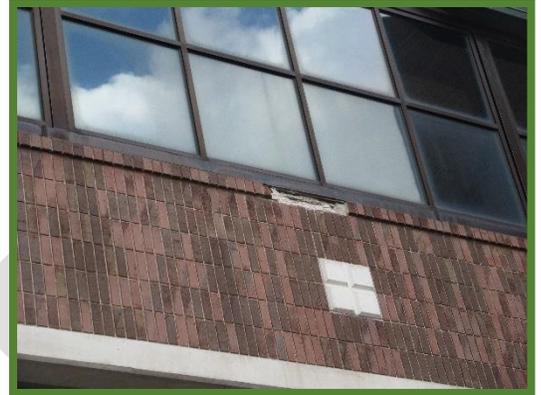
Masonry

The exterior façade consists of precast concrete and brick masonry. The brick masonry appears to be in good condition, with some small areas deterioration observed. Spalls were observed at the brick at the steps in the northeast corner and on the east face of the pedestrian bridge. All loose bricks should be repaired to help prevent future deterioration.

The brick stair retaining wall at the northwest corner was rebuilt in 2005. A crack in the north face of the wall has developed. The cove joint sealant between the brick and steps has failed, causing moisture to enter the backside of the wall. Thermal movement of the concrete steps and freeze-thaw has most likely caused this crack.

- 4.1 *Brick Repair* – This item includes repairing the deteriorated bricks at the pedestrian bridge and the northwest stairs.
- 4.2 *Repoint Mortar Joints* – This item includes repointing the failed/deteriorated mortar joints at the masonry wall at the perimeter of the parking structure and pedestrian bridge.

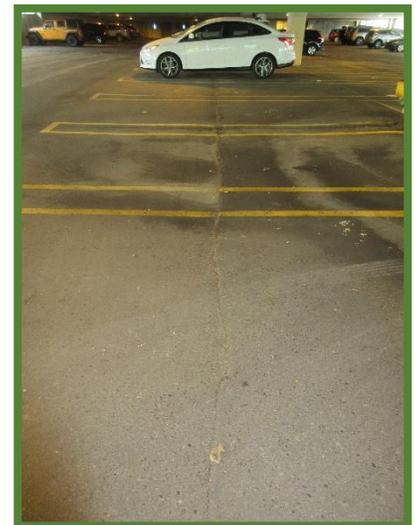
The Lower Level is at grade and the floor surface consists of asphalt. The asphalt throughout this level is in good condition, with approximately 240 square feet of deterioration. The paving seams are opening up which may lead to future deterioration of the asphalt. The asphalt should be repaired to reduce future deterioration and trip hazards.

- 32.1 *Asphalt Repair* – This includes repairing the deteriorated asphalt at the Lower Level.
- 32.2 *Seal Asphalt Cracks/Joints* – This includes routing and sealing all cracks/joints in the asphalt at the Lower Level.
- 32.3 *Pavement Markings* – This includes repainting the pavement markings after the application of a concrete sealer or a deck coating.
- 32.4 *Install Railing Post Covers* - This includes installing post covers on the railing at the Upper Level where they are missing.
- 32.5 *Fence Repair* - This includes repairing the fence.

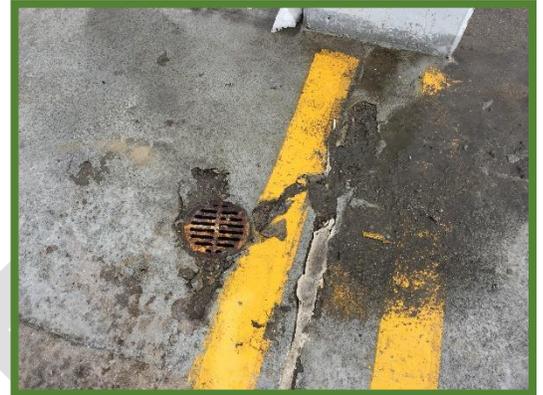
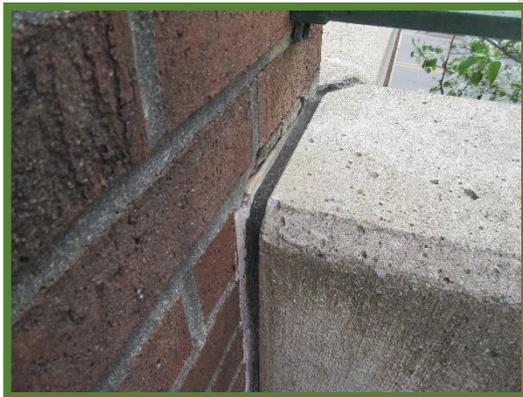
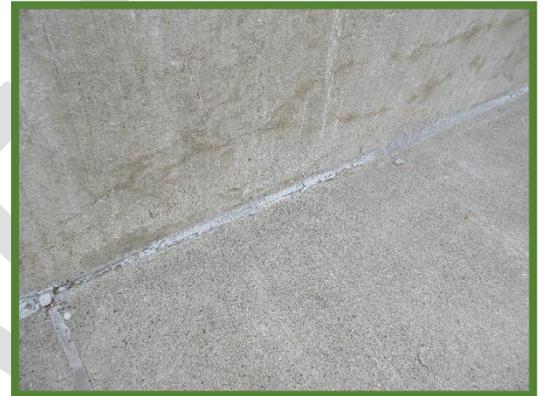
Joint Sealants

It is our understanding that a small quantity of the tee-to-tee joint sealants were repaired in 2005 and 2013. Failed tee-to-tee joint sealants and active leaking were observed throughout the Upper Level.

Cove joint sealants are typically installed at the slab-to-wall joints and at the slab-to-curb joints at the perimeter of the structure. The cove joint sealants are in poor condition and appear to have been damaged by snow plows.

Vertical wall sealants at the interior and exterior of the structure are in poor condition. Cracked and weathered sealants were observed throughout the structure. Most of the wall sealants are located at the columns.

Most of these sealants appear to be very old and are at the end of their useful life. The typical service life for joint sealants is 7 to 10 years, especially at the roof level. Sealants should be repaired to prevent the infiltration of moisture and chlorides into the structural elements below and to prevent leaking onto vehicles and pedestrians at the Lower Level.

- 7.1 *Rout & Seal Cracks* – This item includes routing and sealing all cracks in the concrete floor topping.
- 7.2 *Remove & Replace Control Joint Sealants* – This item includes removing and replacing all tee-to-tee control joint sealants and all other construction/control joint sealants.

- 7.3 *Remove & Replace Cove Joint Sealants* – This item includes removing and replacing all cove joint sealants.
- 7.4 *Remove & Replace Interior Wall Sealant* – This item includes removing and replacing all wall joint sealants at the interior of the structure.

- 7.5 *Remove & Replace Exterior Wall Sealant* – This item includes removing and replacing all joint sealants at the façade of the structure.
- 7.6 *Remove & Replace Expansion Joint Sealant* – This item includes removing and replacing the expansion joint gland at the entrance and exit to the Upper Level.

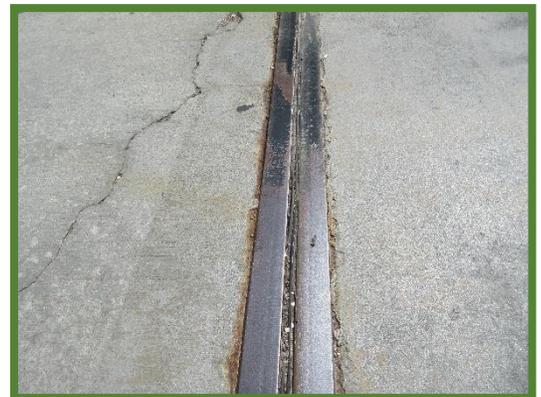
Expansion Joints

There is an expansion joint running east-west at the entrance/exit to the Upper Level. The purpose this joint is to provide isolation from the structural slab and the foundation which allows movement to occur without causing damage to the structure. The joint consists of steel angles with a compression seal (Jeene Joint). The gland was replaced in 2013. The gland has failed causing leaking below and corrosion damage to the foundation wall. This gland should be replaced to prevent water from damaging the structural elements.

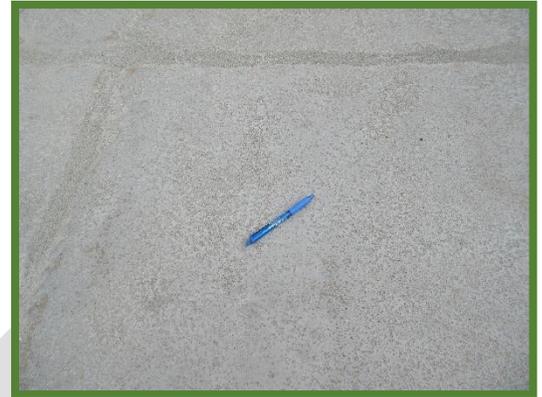
Surface Treatments

Deck coating has been installed at the Upper Level slab directly above the inverted tee beams at column line B and along the north edge of the structure. It is our understanding that the deck coating was replaced in the 2005 project. The deck coating appears to be in fair condition with many worn areas, especially in the drive lanes. All of the deck coating should be recoated to help protect the underlying structural concrete elements.

It is our understanding that a 40% silane sealer was applied to the Upper Level slab surfaces during the 2005 repair project. The effective service life of a 40% silane sealer is typically 4 to 5 years.

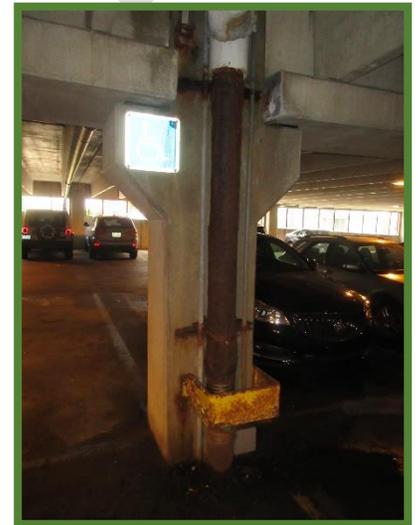
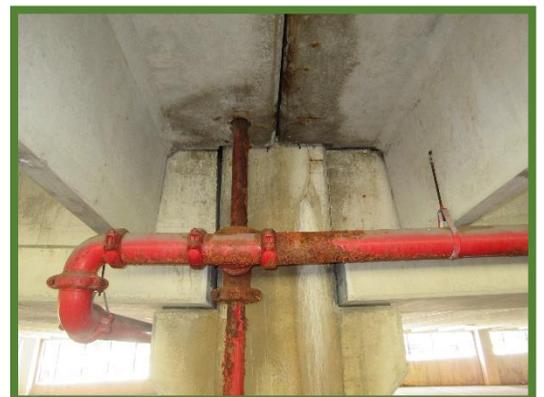
Mechanical

Cast iron storm drainage piping (vertical risers) are at three locations in the structure, all along column line B. Corroded and damaged cast iron piping were noted at all locations, caused by leaking joints above. The piping should be replaced to maintain proper water removal from the structure. The piping could be replaced with PVC to eliminate the corrosion damage, if allowed by the local codes.

The steel pipe guards protecting these risers were observed to be corroded. As a minimum, these should be cleaned and repainted or better yet, replaced with new galvanized pipe guards.

The standpipe system has been painted, which helps protect the steel from corrosion. Most of this paint is deteriorating, causing corrosion. The standpipe system should be cleaned and repainted. The system should also be tested, if it has not been recently, to make sure it is working properly.

- 9.4 *Clean & Paint Standpipe System* – This item includes cleaning and painting the standpipe system at both levels to help protect it from corrosion.

- 9.5 *Clean & Paint Pipe Guards* – This item includes cleaning and painting the pipe guards at the Lower Level to help protect them from corrosion.
- 9.6 *Touch-up Paint at Northeast Stair Tower* – This item includes touching up the paint on the damaged portions of the walls, stair pans, and handrails as needed at the northeast stair tower.

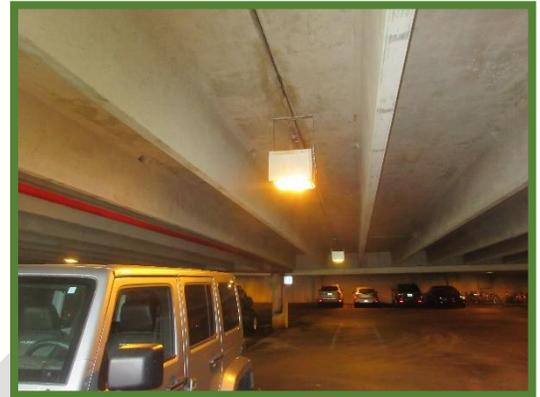
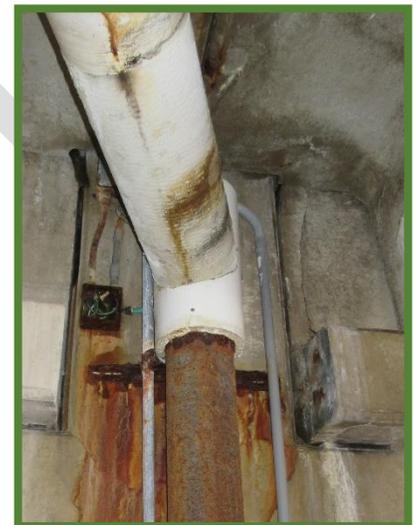
HPS light fixtures at the Lower Level are located near the edge of each drive lane at a spacing of 30 feet. The fixtures are surface mounted to the underside of the slabs and are serviced by exposed electrical conduit. The lighting system appears to be in good working order. WGI can conduct a lighting survey to review existing lighting levels and make recommendations to improve (increase) lighting levels while using more energy efficient fixtures. LED lighting technology is available that could provide energy savings as well as a longer bulb life.

Electrical junction boxes and conduits were noted to be corroded due to leaking joints above. Some of the boxes were missing covers exposing the wires. The conduits and junction boxes should be repaired to prevent future deterioration and possible electrocution.

- 26.1 *Replace Damaged Conduit & Junction Boxes* – This item includes replacing the corroded electrical conduits and junction boxes at the Lower Level.

- O5. *Replace Light Fixtures* - LED lighting technology is available that could provide energy savings as well as a longer bulb life. WGI can run lighting software to determine if the fixture spacing is adequate for the IES recommendations. The rate of return would most likely be in 3 to 5 years.

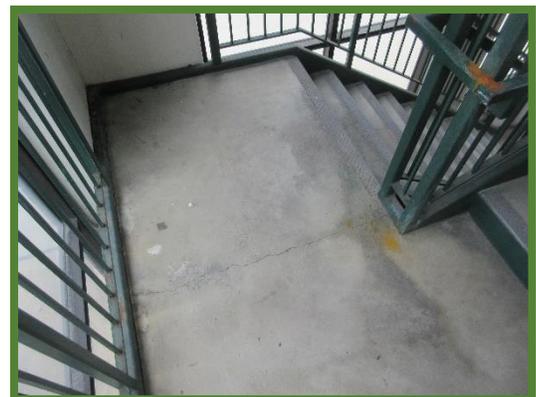
The following items were noted at the northeast stair tower:

- Cracks in many of the concrete treads and landings, which need to be sealed.
- Paint stained and peeling at some of the concrete walls.
- Handrails and metal pans have some corrosion.
- Door hinge badly corroded at the Upper Level.
- Roof appears to have a leak.
- Failed sealant at the east window at the Upper Level.
- Paint peeling from the interior ceiling of the pedestrian bridge.

- 7.9 *Crack Repair at Treads/Landings* – This item includes sealing the cracks in the concrete treads and landings at the northeast stair tower.
- 7.10 *Roof Repair* – This item includes repairing the leak in the northeast stair tower roof.

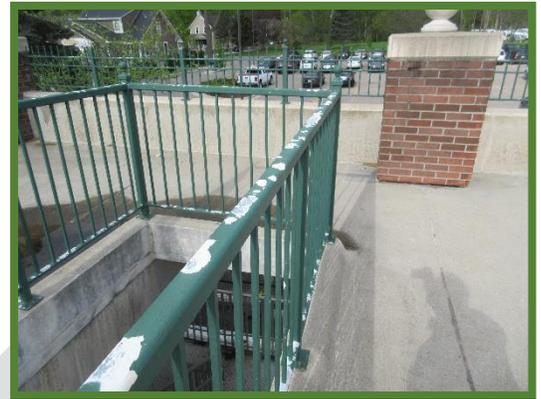
The following items were noted at the southwest stair tower:

- Paint peeling from the rail around the stairs at the Upper Level.
- One riser missing from the stairs.
- Bottom of door frame corroded at the Lower Level.

- 5.1 *Install Stair Riser* – This item includes installing a stair riser that is missing at the southwest stairs.

- 5.2 *Repair Doors* – This item includes replacing the corroded door hinge at the northeast stair tower and repairing corroded door frame at the southwest stairs
