Executive Committee Meeting
Wednesday, August 8, 2018
City Manager's Conference Room – 8:00 am

CITY OF NORTHVILLE

24183249.00 | August 6, 2018 | Engineering Condition Assessment

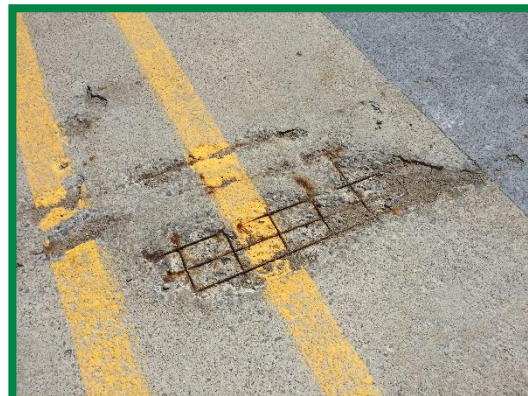
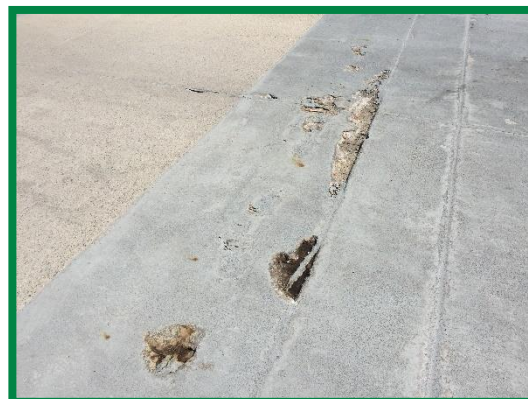
A representative chain drag survey of the floor slab was performed to locate and quantify concrete delaminations. A delamination is a horizontal fracture beneath the surface of the concrete. In general, slab delaminations are caused by corrosion of the embedded reinforcing steel. Rust, which is the byproduct of the corrosion process, has a volume several times that of the original steel. The volume change created by corrosion generates pressures on the surrounding concrete that eventually becomes sufficient to cause internal fracturing of the concrete and the loss of bond of the corroded reinforcing steel with the surrounding concrete.

The chain drag survey of the floor slab revealed approximately 1,100 square feet of slab delaminations at the Upper Level, which is approximately 4.5% of the supported slab. The floor slab delaminations range in size from approximately 1 to 40 square feet. Many of the delaminations are caused by the corrosion of the welded wire fabric which appears to have very little concrete cover. Floor slab delaminations should be repaired to help maintain the structural integrity of the facility and eliminate safety hazards such as trip hazards.

- 3.1 *Top of Slab Repair* – This item includes repairing the delaminated/spalled concrete in the concrete topping at the Upper Level.
- 3.2 *Tee Flange Repair* – This item includes repairing delaminated concrete at the underside of the precast tee flanges (Lower Level ceiling).
- 3.3 *Tee Stem Repair* – This item includes repairing delaminated concrete at the precast tee stems.
- 3.4 *Beam Repair* – This includes the repair of beam delaminations at the underside of the Upper Level.
- 3.5 *Column Repair* – This item includes the repair of column delaminations throughout the structure.
- 3.6 *Spandrel Repair* - This item includes repairing delaminated concrete at the precast spandrels.
- 3.7 *Wall Repair* - This item includes repairing delaminated concrete at the walls.
- 3.8 *Curb Repair* - This item includes the repair of curb delaminations at the entrance/exit at the Upper Level.

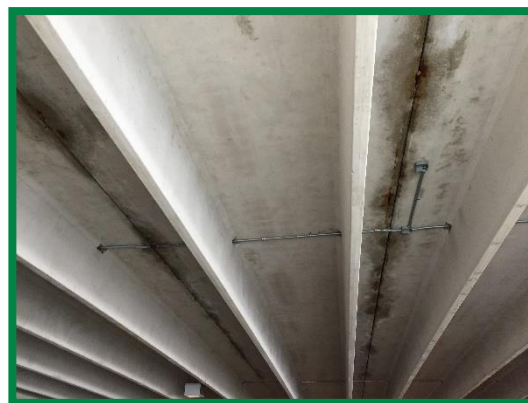
Tee Flanges/Stems

The double tees appear to be in good condition. We estimate a total of 80 square feet of tee flange delaminations, with most of them approximately 1 to 4 square feet in size. The delaminations are typically located along leaking joints that allow water and chlorides to corrode embedded reinforcement. These delaminations should be repaired to help maintain the structural integrity of the facility and eliminate safety issues such as falling concrete.

The tee stems appear to be in good condition. We estimate a total of 10 square feet of tee flange delaminations, with most of them approximately 1 to 2 square feet in size. These delaminations should be repaired to help maintain the structural integrity of the facility and eliminate safety issues such as falling concrete.

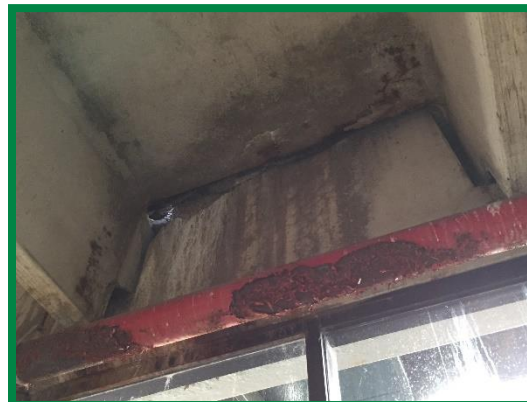
Beams

The beams appear to be in good condition. We estimated a total of 10 square feet of delaminations, with most of them approximately 1 to 5 square feet in size. The delaminations are typically located along leaking joints that allow water and chlorides to corrode embedded reinforcement. These delaminations should be repaired to help maintain the structural integrity of the facility and eliminate safety issues such as falling concrete.

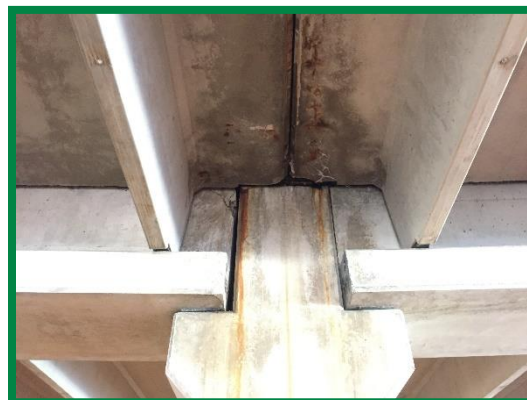
Columns

The columns appear to be in good condition with an estimated total of 10 square feet of delaminations. Most of the delaminations are small, approximately 1 to 2 square feet in size, and primarily located at the Lower Level adjacent leaking floor drains and risers. These delaminations should be repaired to help maintain the structural integrity of the facility and eliminate safety issues such as falling concrete.

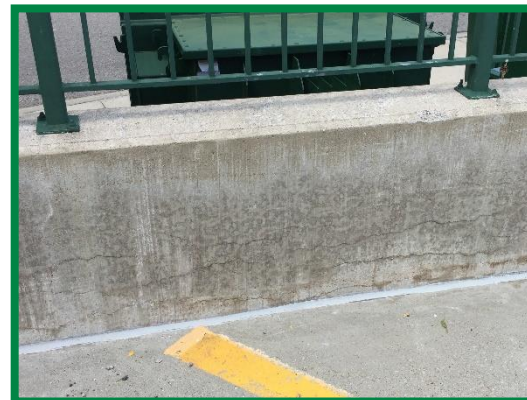
Spandrels

The precast concrete spandrels with brick veneer are located at the perimeter of the Upper Level. The spandrels appear to be in good condition with an estimated total of 10 square feet of delaminations. Most of the delaminations are small, approximately 1 to 2 square feet in size and primarily located near the columns. The delaminations at the interior face are typically caused by the corrosion of the reinforcement with shallow concrete cover. The deterioration at the exterior face appear to be caused by failed sealants, which allows moisture to penetrate behind the brick veneer. The moisture can then attack the concrete causing corrosion of the reinforcement, especially if there is shallow concrete cover on this face. Also, once moisture is behind the brick, freeze-thaw can cause damage to the concrete and the brick.

We observed areas of multiple hairline cracks at the interior face of the spandrels, which may be from alkali-silica reaction (ASR). To help protect these areas we would recommend installing a concrete sealer.

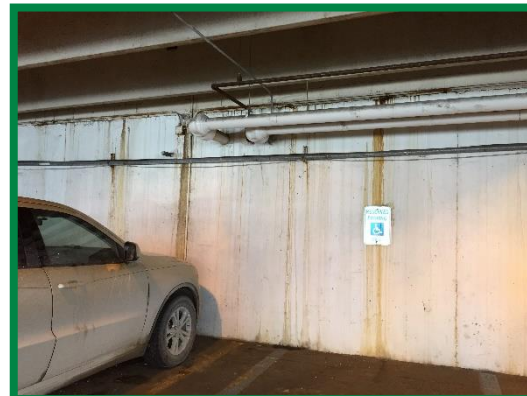
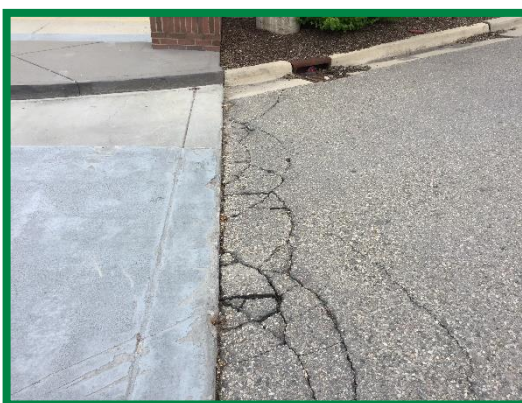
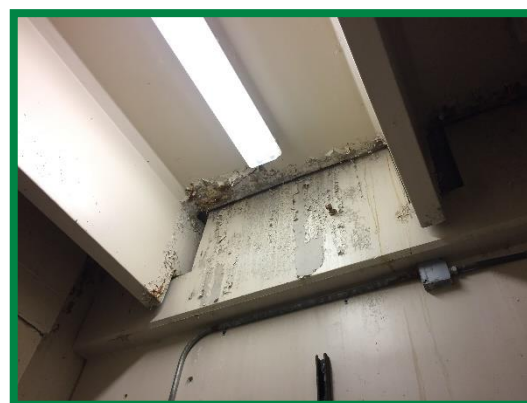
Walls

The cast-in-place concrete walls are located at the perimeter of the Lower Level. The walls appear to be in good condition with an estimated total of 10 square feet of delaminations. Most of the wall delaminations are small, approximately 1 to 4 square feet in size. The wall at the north end has a few leaking cracks that should be sealed to protect the wall from further delaminations. Also, there is leaking onto the north wall below the concrete-to-asphalt joint at the Upper Level entrance/exit and below the isolation joints at the northeast stair tower (elevator/electrical room). These joints above should be repaired to prevent the infiltration of water and chlorides.

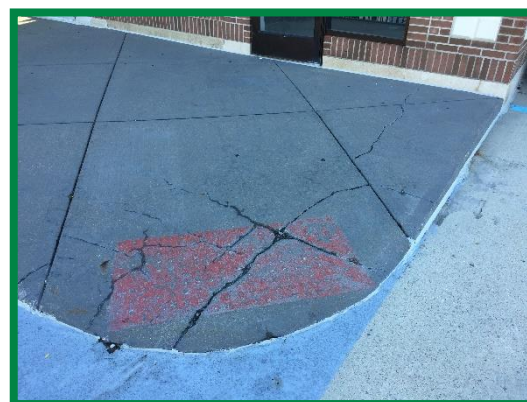
Curbs

The concrete curbs are in fair condition with approximately 20 square feet of delaminations noted at the Upper Level. All of the curb delaminations were observed at the entrance/exit. The concrete curbs help direct water to the floor drains and provides a walking surface for pedestrians. These delaminations should be repaired to prevent potential trip hazards and to protect the embedded steel reinforcement.

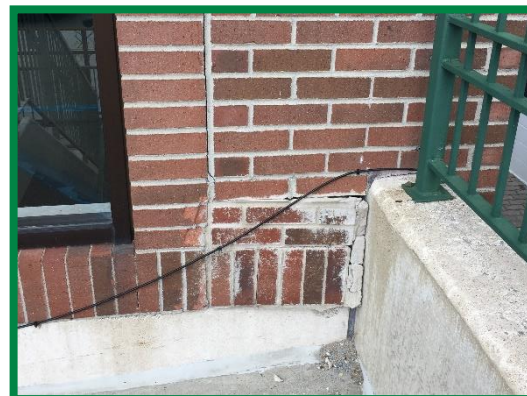
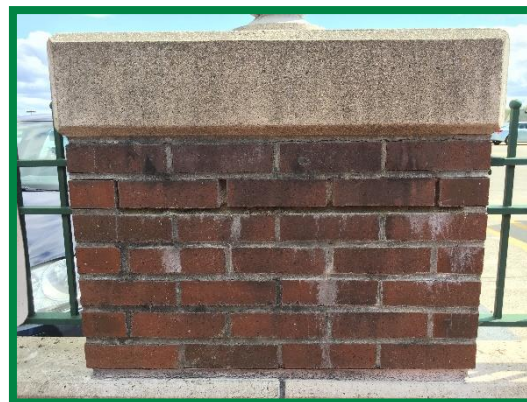
Masonry

The exterior façade consists of precast concrete and brick masonry. The brick masonry appears to be in good condition, with some small areas deterioration observed. We observed spalls at the northeast stair tower and deteriorated mortar joints at the north exterior columns. All loose bricks and deteriorated mortar joints should be repaired to help prevent future deterioration.

- 4.1 *Brick Repair* – This item includes repairing the deteriorated bricks at the façade of the structure.
- 4.2 *Repoint Mortar Joints* – This item includes repointing the failed/deteriorated mortar joints of the masonry walls at the façade of the structure.

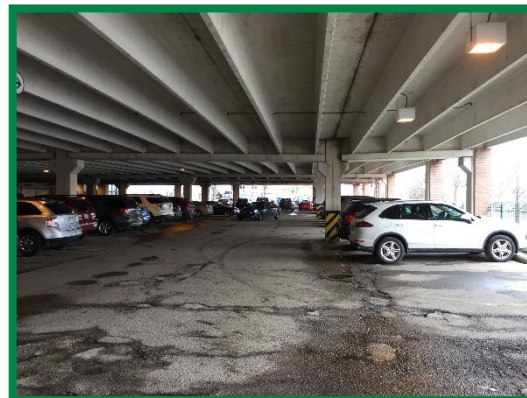
Asphalt

The Lower Level is at grade and the floor surface consists of asphalt. The asphalt throughout this level appears to be in fair condition with approximately 6,600 square feet of deterioration, which is approximately 24% of the floor surface. The paving seams are opening up which may lead to future deterioration of the asphalt. The asphalt should be repaired to reduce future deterioration and trip hazards.

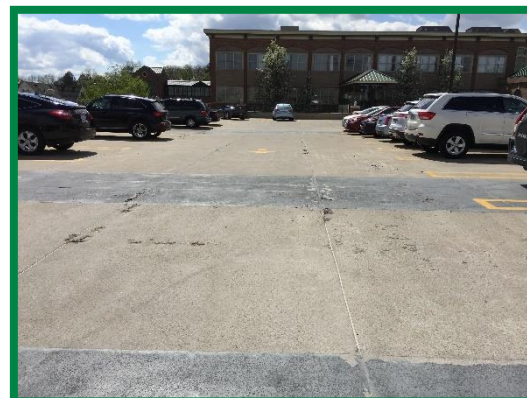
Joint Sealants

It is our understanding that a small quantity of the tee-to-tee joint sealants were repaired in 2005 and 2013. Failed tee-to-tee joint sealants and active leaking were observed throughout the Upper Level.

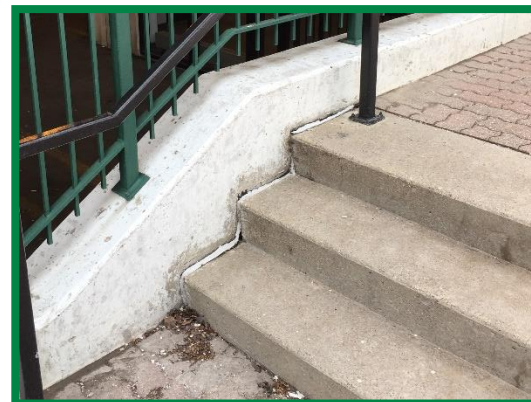
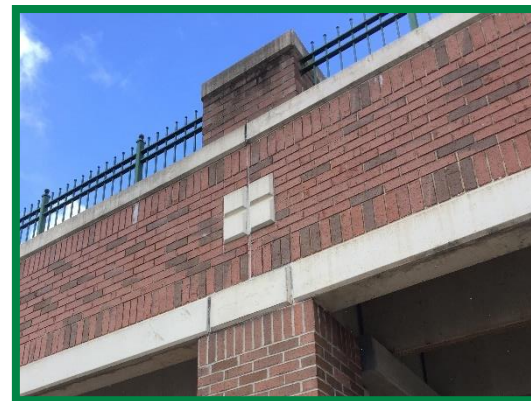
Cove joint sealants are typically installed at the slab-to-wall joints and slab-to-curb joints at the perimeter of the structure. The cove joint sealants appear to be in good condition throughout the Upper Level; they appear to have been recently replaced. Cracked and weathered sealants were observed at the exterior stairs and the pedestrian bridge.

Vertical and horizontal wall sealants at the interior and exterior of the structure are in poor condition. Cracked and weathered sealants were observed throughout the structure. Most of the wall sealants are located at the columns.

The typical service life for joint sealants is 7 to 10 years, especially at the roof level. Sealants should be repaired to prevent the infiltration of moisture and chlorides into the structural elements below and to prevent leaking onto vehicles and pedestrians at the Lower Level.

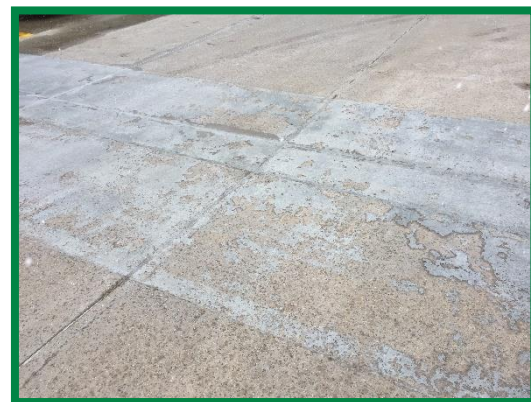
Surface Treatments

Deck coating has been installed at the Upper Level slab directly above the inverted tee beams along column lines B, C, and D, and at the entrance/exit. It is our understanding that the deck coating was replaced in the 2005 repair project. The deck coating appears to be in poor condition with many worn areas, especially in the drive lanes. All of the deck coating should be recoated to help protect the underlying structural concrete elements.

It is our understanding that a 40% silane sealer was applied to the Upper Level slab surfaces during the 2005 repair project. The effective service life of a 40% silane sealer is typically 4 to 5 years.

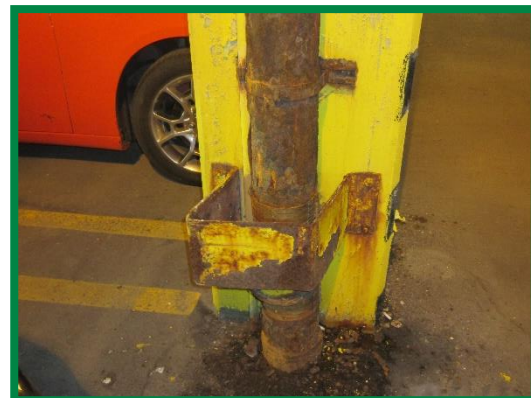
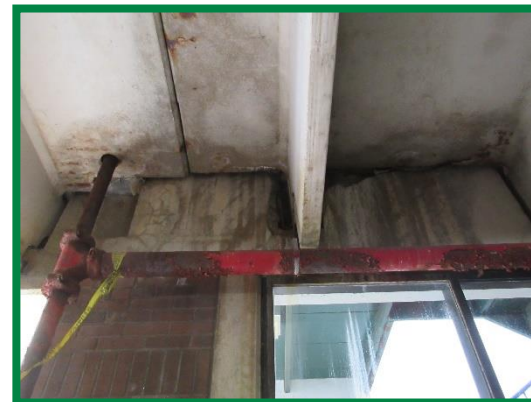
Mechanical

Cast iron storm drainage piping (vertical risers) are at four locations in the structure, along column lines B and D. Corroded and damaged cast iron piping were noted at three of the four locations, caused by leaking joints above. The damaged piping should be replaced to maintain proper water removal from the structure. Piping could be replaced with PVC to eliminate corrosion damage, if allowed by the local codes.

The steel pipe guards protecting the risers were all observed to be corroded. As a minimum, these should be cleaned and repainted or better yet, replaced with new galvanized pipe guards.

The standpipe system has been painted, which helps protect the steel from corrosion. Most of this paint is deteriorating, causing corrosion. The standpipe system should be cleaned and repainted. A section of severely corroded standpipe near the northwest stair tower should be replaced to maintain the proper function of the system. The system should also be tested, if it has not been recently, to make sure it is working properly.

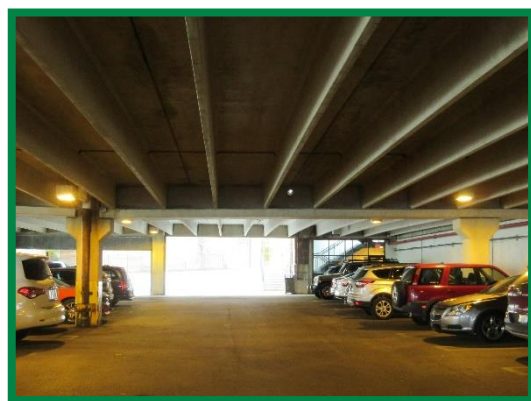
HPS light fixtures at the Lower Level are located near the edges of the drive lane at a spacing of approximately 30 feet. The fixtures are surface mounted to the underside of the slab and are serviced by exposed electrical conduit. The lighting system appears to be in good working order. WGI can conduct a lighting survey to review existing lighting levels and provide recommendations to improve (increase) lighting levels while using more energy efficient fixtures. LED lighting technology is available that could provide energy savings as well as a longer bulb life.

Electrical junction boxes and conduits were noted to be corroded due to leaking joints above. The conduits and junction boxes should be repaired to prevent future deterioration and possible electrocution.

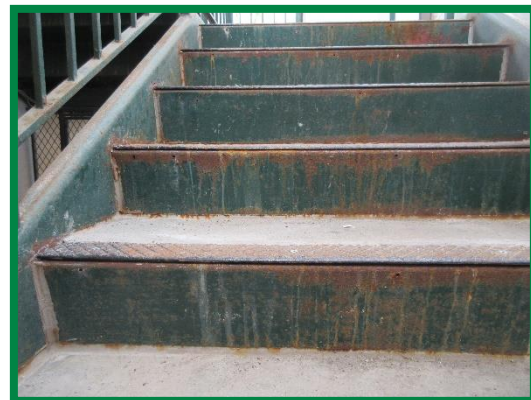
The following items were noted at the northeast stair tower:

- Stairs and handrails were observed to be corroded; steel surfaces should be cleaned and repainted (touch-up only at underside).
- Existing sealant appear to be in good condition.
- Upper Level landing has a mat adhered to the floor. We recommend removing the mat flooring and replacing with cove joint sealants and deck coating.
- A full system deck coating should be added to the stair treads and landings to help protect the underlying structure.
- Exterior door fails to close at the Upper Level and should be repaired.
- Interior paint at walls and ceiling appears to be in good condition.

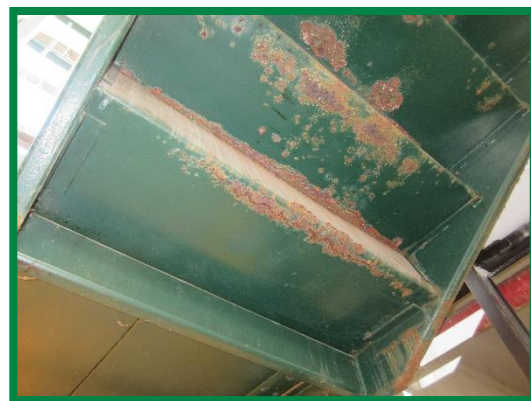
The following items were noted at the northwest stair tower:

- Stairs and handrails were observed to be corroded; steel surfaces should be cleaned and repainted.
- Isolated areas of severe corrosion were observed, including five tread pans and one landing panel that were damaged and should be replaced.
- Existing sealant appear to be in good condition.
- Deck coating has been applied to the floor at the top two landings. The deck coating appears to be in good condition.
- A full system deck coating should be added to the stair treads and untreated landing to help protect the underlying structure.
- Interior paint at walls and ceiling appears to be in good condition.

- 5.1 *Steel Tread Pan Repair* – This item includes replacing the corroded tread pans at the northwest stair tower.
- 5.2 *Steel Landing Panel Repair* – This item includes replacing the corroded landing panel at the northwest stair tower.
- 5.3 *Door Repair* – This item includes repairing the door at the northeast stair tower.

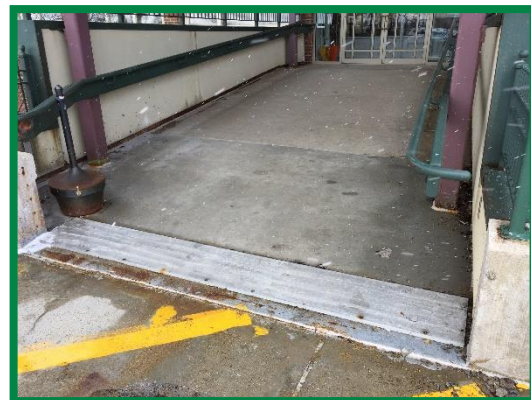
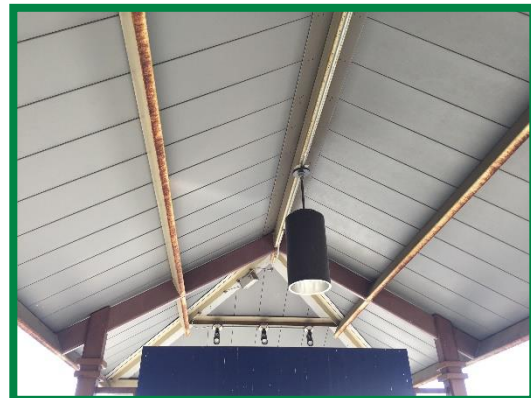
Pedestrian Bridge

The pedestrian bridge appears to be in relatively good condition. The bridge is not original to the structure and was constructed of steel framing members, standing seam metal roof, concrete supported slab, and cement board ceiling at the underside of bridge.

The following items were noted at the pedestrian bridge:

- Cracked and weathered sealants should be replaced.
- Existing deck coating at the bridge floor is worn and should be recoated.
- A full system deck coating should be added to the untreated floor area to help protect the underlying structure.
- Tube Steel (columns, beams and handrails) was observed to be corroded; steel surfaces should be cleaned and repainted.

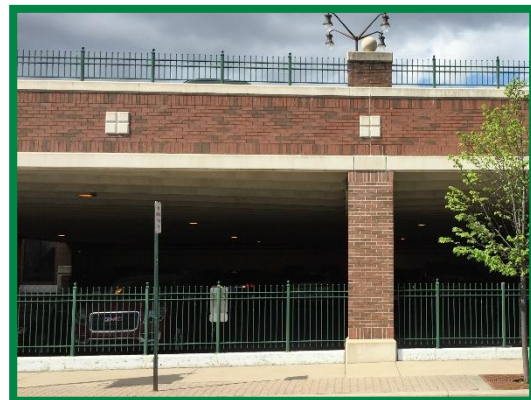
Perimeter Railing

The steel railings around the perimeter of both levels were observed to be corroded in areas with peeling paint throughout. As a minimum, these corroded areas should be cleaned and repainted.

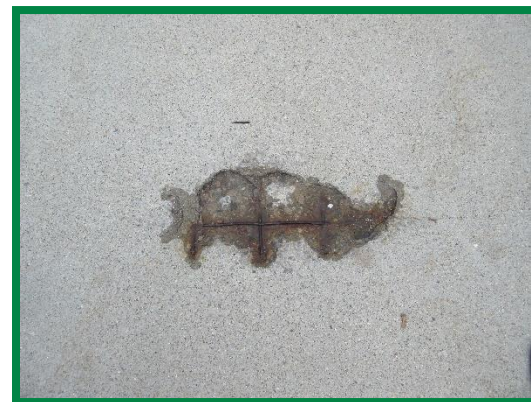
A representative chain drag survey of the floor slab was performed to locate and quantify concrete delaminations. A delamination is a horizontal fracture beneath the surface of the concrete. In general, slab delaminations are caused by corrosion of the embedded reinforcing steel. Rust, which is the byproduct of the corrosion process, has a volume several times that of the original steel. The volume change created by corrosion generates pressures on the surrounding concrete that eventually becomes sufficient to cause internal fracturing of the concrete and the loss of bond of the corroded reinforcing steel with the surrounding concrete.

The chain drag survey of the floor slab revealed approximately 400 square feet of slab delaminations at the Upper Level, which is approximately 1.4% of the supported slab. Most of the top-of-slab delaminations are small, approximately 1 to 4 square feet in size. Many of the delaminations are caused by the corrosion of the welded wire fabric which appears to have very little concrete cover. Floor slab delaminations should be repaired to help maintain the structural integrity of the facility and eliminate safety hazards such as trip hazards.

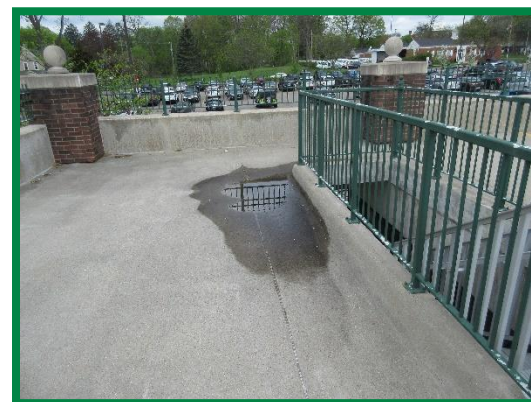
Water ponding was observed at the Upper Level Adjacent to the southwest stairs. This ponding could be relieved by minor re-profiling or installing a supplementary floor drain.

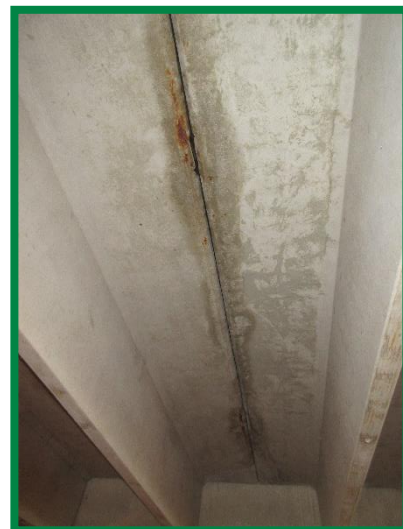
The tee stems appear to be in good condition. No delaminations were noted at the stems.

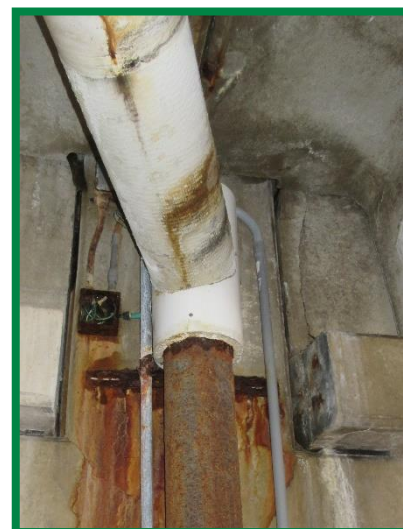
Beams

The inverted tee beams running column line B appear to be in good condition with an estimated total of 30 square feet of delaminations. Most of the delaminations are small, approximately 1 to 2 square feet in size and primarily located near the columns. The delaminations are typically located at leaking joints that allow water and chlorides to corrode embedded reinforcement. These delaminations should be repaired to help maintain the structural integrity of the facility and eliminate safety issues such as falling concrete.

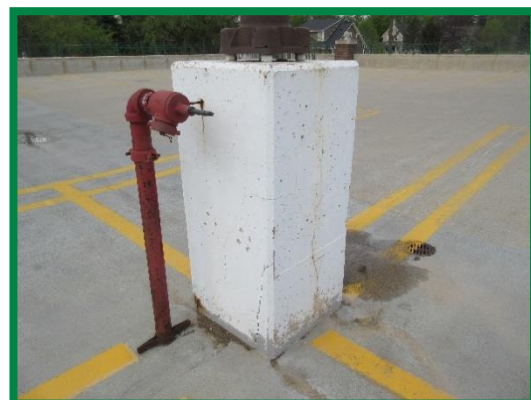
The interior columns at the Upper Level, a total of three, are used to support the light posts. These columns have multiple hairline cracks, which may be from alkali-silica reaction (ASR). To help protect these columns we would recommend installing an elastomeric coating.

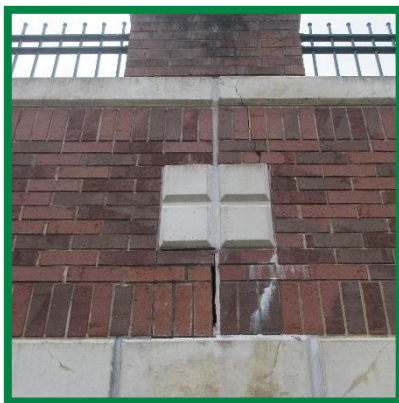
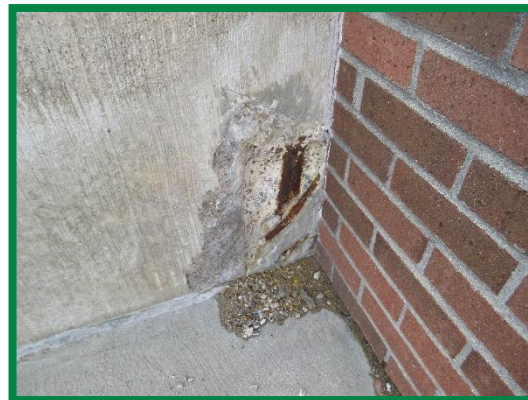
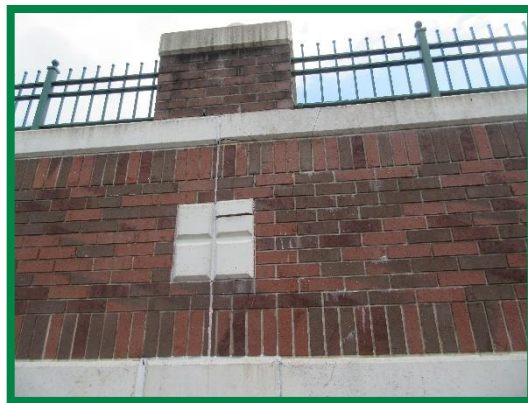
Spandrels

The precast concrete spandrels with brick veneer are located at the perimeter of the Upper Level. The spandrels appear to be in good condition with an estimated total of 30 square feet of delaminations. Most of the delaminations are small, approximately 1 to 2 square feet in size and primarily located near the columns. The delaminations at the interior face are typically caused by the corrosion of the reinforcement with shallow concrete cover. The deterioration at the exterior face appear to be caused by failed sealants, which allows moisture to penetrate behind the brick veneer. The moisture can then attack the concrete causing corrosion of the reinforcement, especially if there is shallow concrete cover on this face. Also, once moisture is behind the brick, freeze-thaw can cause damage to the concrete and the brick.

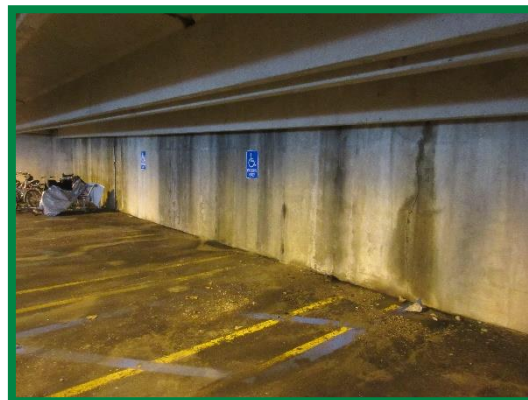
Walls

The cast-in-place concrete walls are located at the perimeter of the Lower Level. The walls appear to be in good condition with an estimated total of 20 square feet of delaminations. Most of the wall delaminations are small, approximately 4 to 6 square feet in size. The wall at the north end has multiple leaking cracks, which has helped cause the delaminations. Also, the expansion joint above at the entrance has failed causing leaking on to the wall. The cracks and expansion joint needs be sealed to protect this wall.

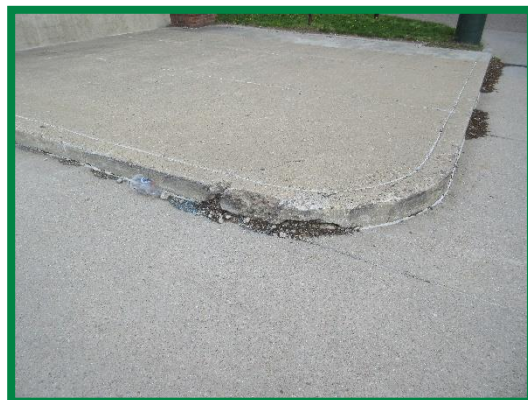
Curbs

The concrete curbs are in good condition with approximately 20 square feet of delaminations noted at the Upper Level. At some locations the deterioration is undermining the curb. All of the curb delaminations were observed at the entrance/exit. The concrete curbs help direct water to the floor drains and provides a walking surface for pedestrians. These delaminations should be repaired to prevent potential trip hazards and to protect the embedded steel reinforcement.

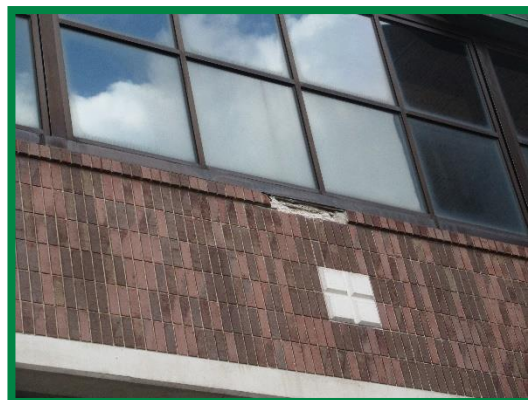
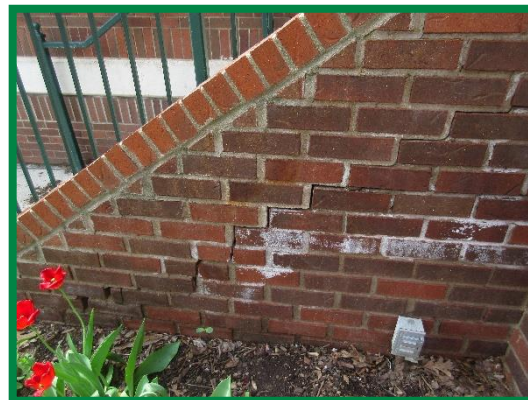
The brick stair retaining wall at the northwest corner was rebuilt in 2005. A crack in the north face of the wall has developed. The cove joint sealant between the brick and steps has failed, causing moisture to enter the backside of the wall. Thermal movement of the concrete steps and freeze-thaw has most likely caused this crack.

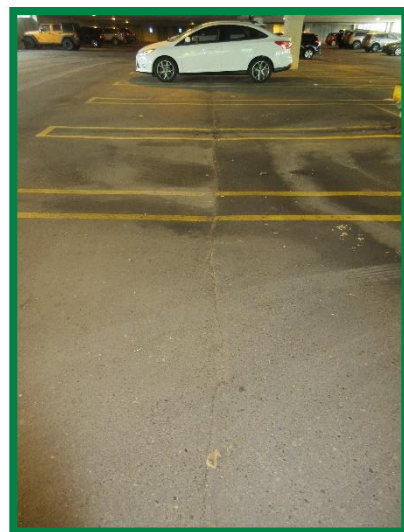
Asphalt

The Lower Level is at grade and the floor surface consists of asphalt. The asphalt throughout this level is in good condition with approximately 240 square feet of deterioration, which is approximately 0.9% of the floor surface. The paving seams are opening up which may lead to future deterioration of the asphalt. The asphalt should be repaired to reduce future deterioration and trip hazards.

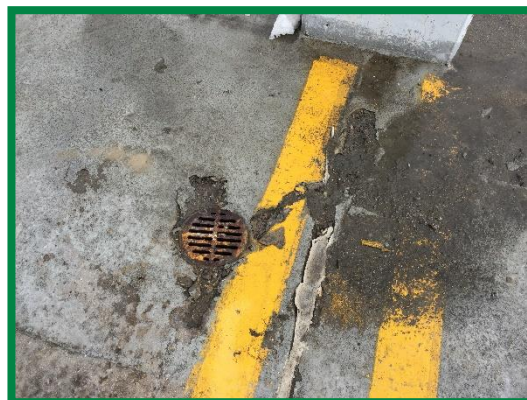
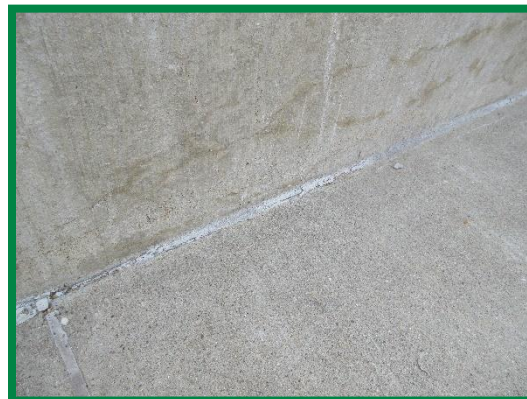
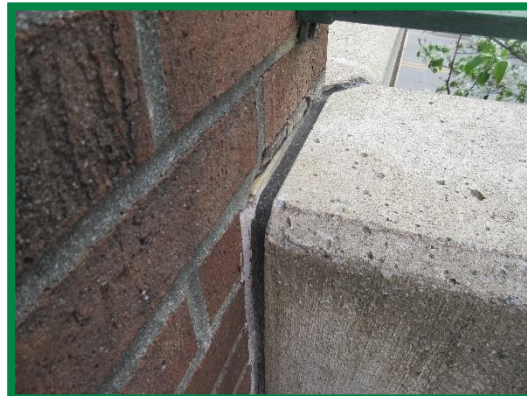
Most of these sealants appear to be very old and are at the end of their useful life. The typical service life for joint sealants is 7 to 10 years, especially at the roof level. Sealants should be repaired to prevent the infiltration of moisture and chlorides into the structural elements below and to prevent leaking onto vehicles and pedestrians at the Lower Level.

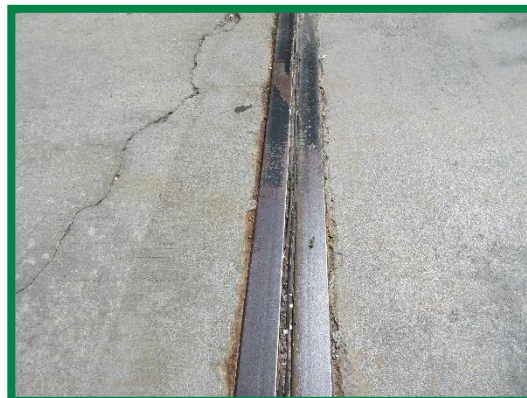
Expansion Joints

There is an expansion joint running east-west at the entrance/exit to the Upper Level. The purpose this joint is to provide isolation from the structural slab and the foundation which allows movement to occur without causing damage to the structure. The joint consists of steel angles with a compression seal (Jeene Joint). The gland was replaced in 2013. The gland has failed causing leaking below and corrosion damage to the foundation wall. This gland should be replaced to prevent water from damaging the structural elements.

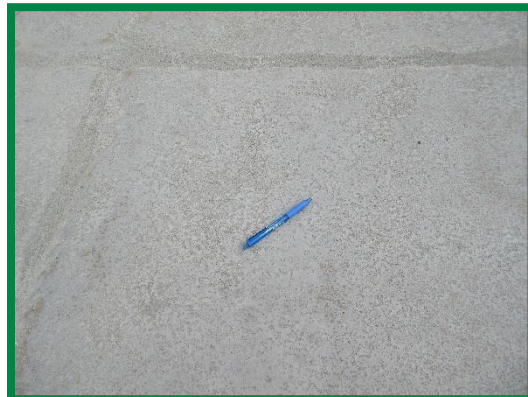
It is our understanding that a 40% silane sealer was applied to the Upper Level slab surfaces during the 2005 repair project. The effective service life of a 40% silane sealer is typically 4 to 5 years.

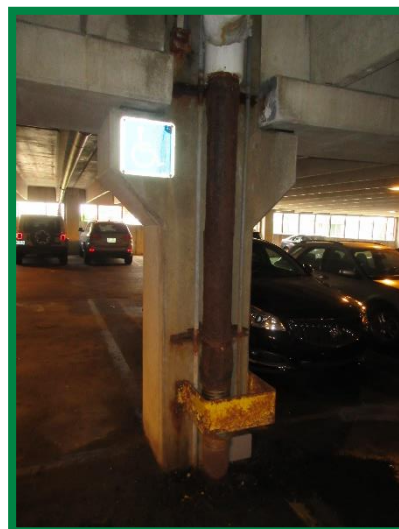
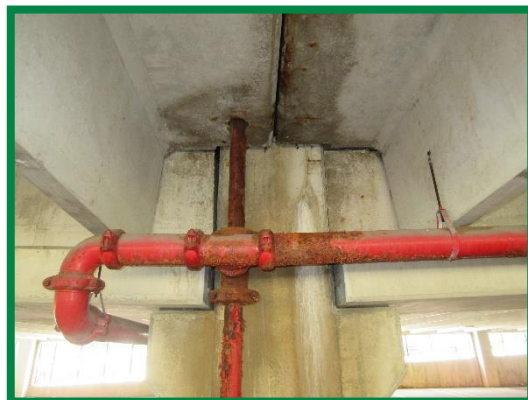
The standpipe system has been painted, which helps protect the steel from corrosion. Most of this paint is deteriorating, causing corrosion. The standpipe system should be cleaned and repainted. The system should also be tested, if it has not been recently, to make sure it is working properly.

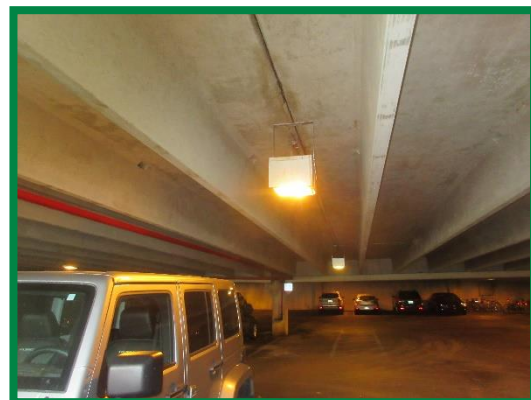
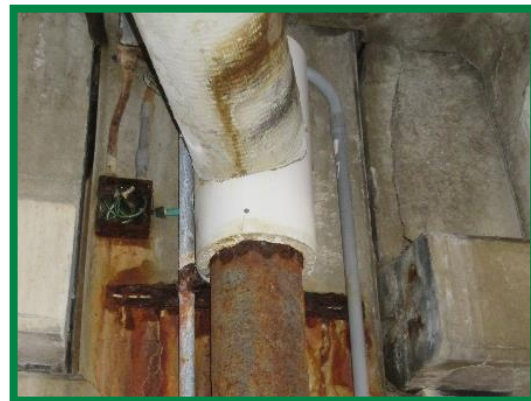
Electrical junction boxes and conduits were noted to be corroded due to leaking joints above. Some of the boxes were missing covers exposing the wires. The conduits and junction boxes should be repaired to prevent future deterioration and possible electrocution.

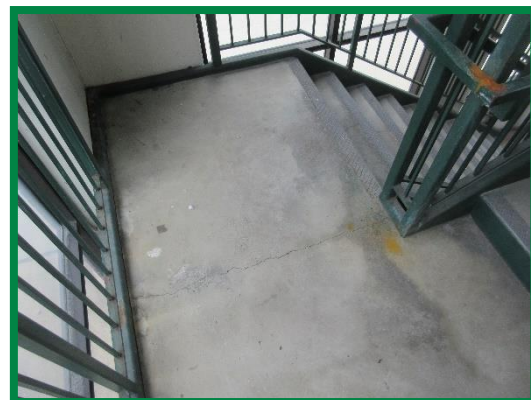
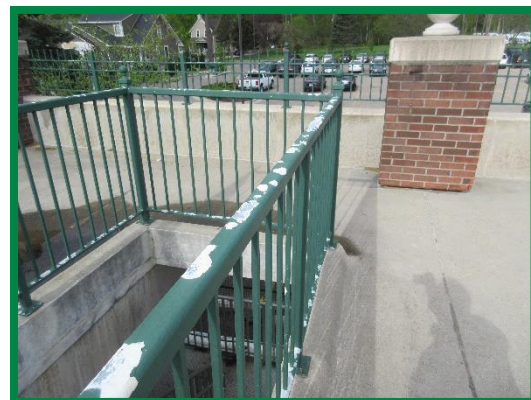
- Paint peeling from the rail around the stairs at the Upper Level.
- One riser missing from the stairs.
- Bottom of door frame corroded at the Lower Level.

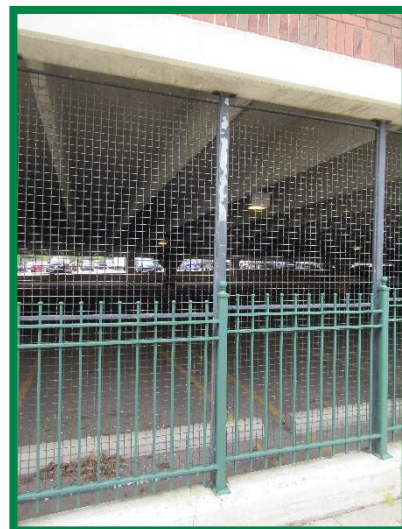
Perimeter Railing & Fencing

The steel railings around the perimeter of both levels and the security fencing around the perimeter of the lower level were observed to be corroded in areas with peeling paint throughout. As a minimum, these corroded areas should be cleaned and repainted.
